Client:	Needham DPW	Dates:	10/14/2019 to 10/18/2019
Contract:	Rosemary Lake Dredging		
Contractor:	Maverick Construction Co., Inc.	Inspector(s) on site:	Caroline Armstrong, Laura Krause, Noel Lioce

### WORK COMPLETED THIS WEEK

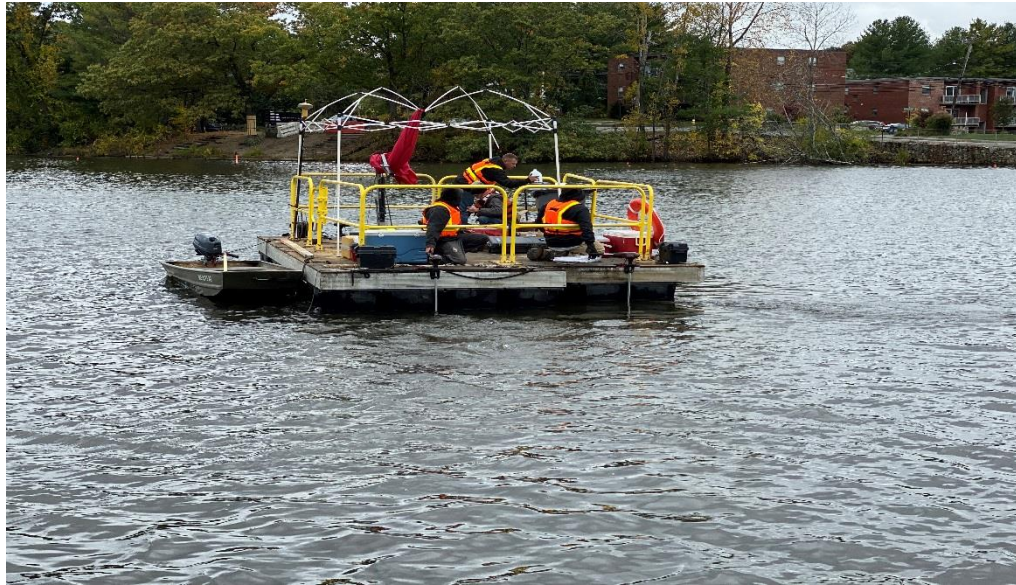
**Maverick collecting sediment samples in Rosemary Lake on sampling platform on Wednesday and Thursday.**

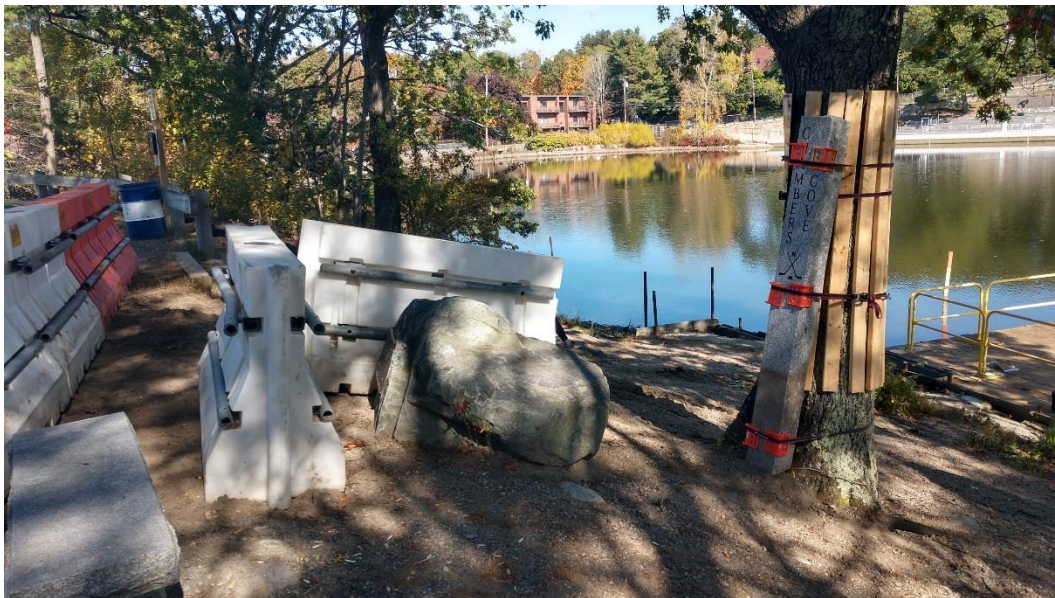
**Maverick set up jersey barriers as protection for memorial at parking/staging area**

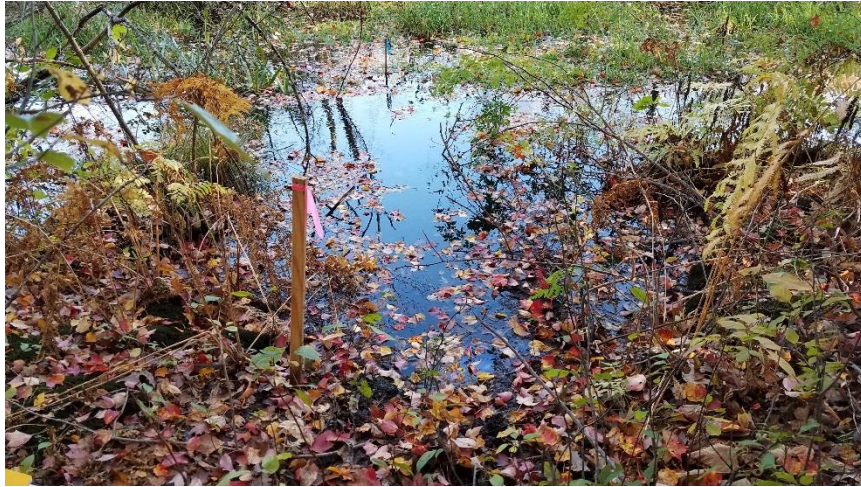
**Station 5.4 (Whalen Property) – Edge of Bank shown. Turbidity, velocity, and sediment depth readings taken on Tuesday (6 days after initiation of drawdown). (10/15/19)**

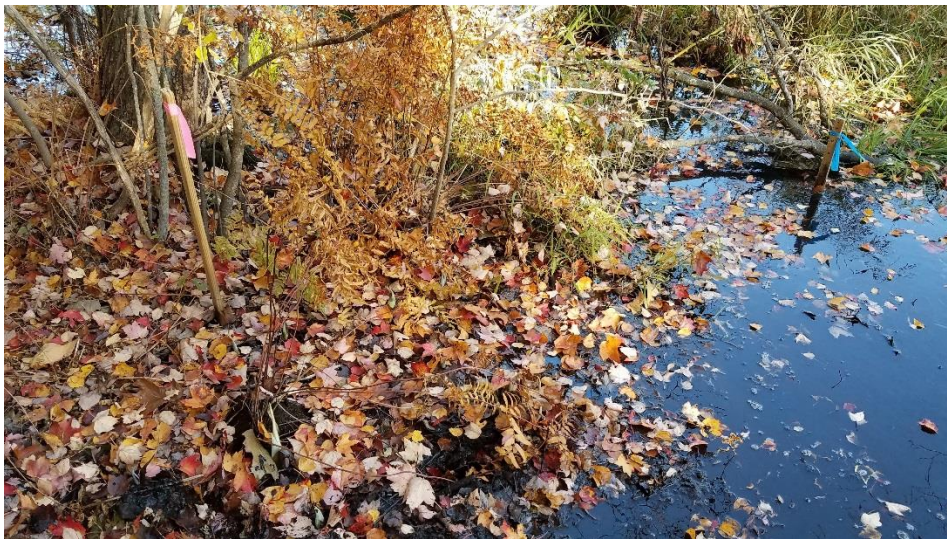
**Station 5.2 (Whalen Property) – Edge of Bank shown. Turbidity, velocity, and sediment depth readings taken on Tuesday (6 days after initiation of drawdown). More vegetation and leaf litter than previous monitoring events. (10/15/19)**

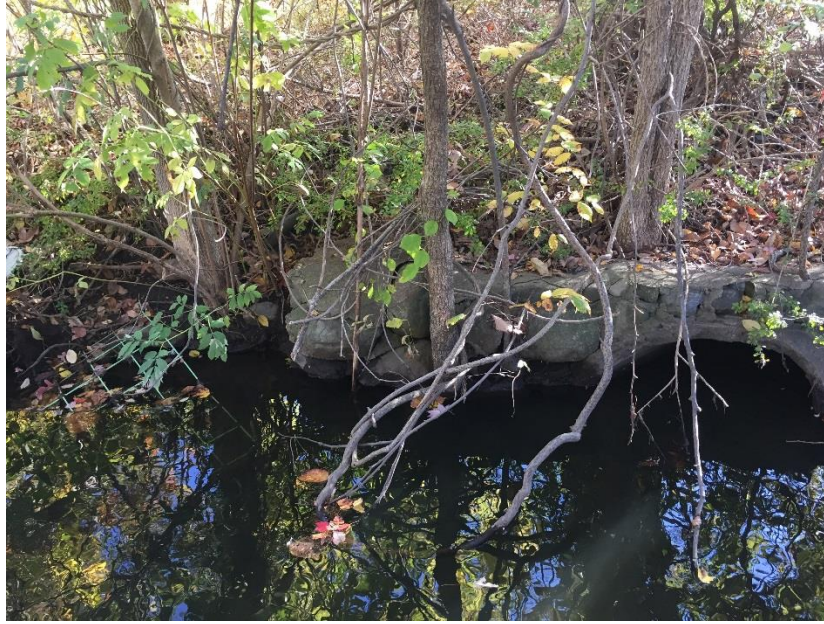
**Station 2 (West Street) – Turbidity, velocity, and sediment depth readings taken on Tuesday (6 days after initiation of drawdown). Stations similar to previous event. (10/15/19)**

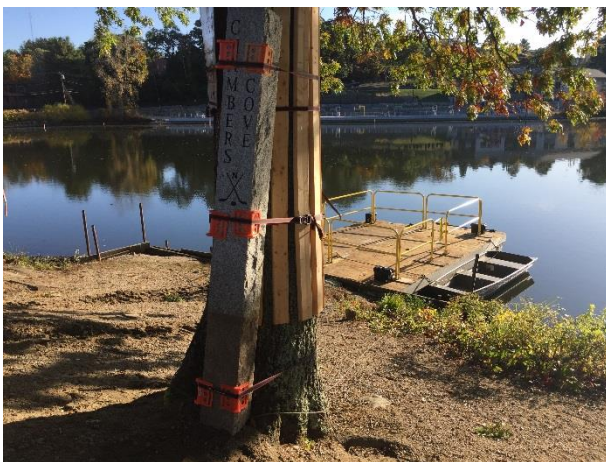
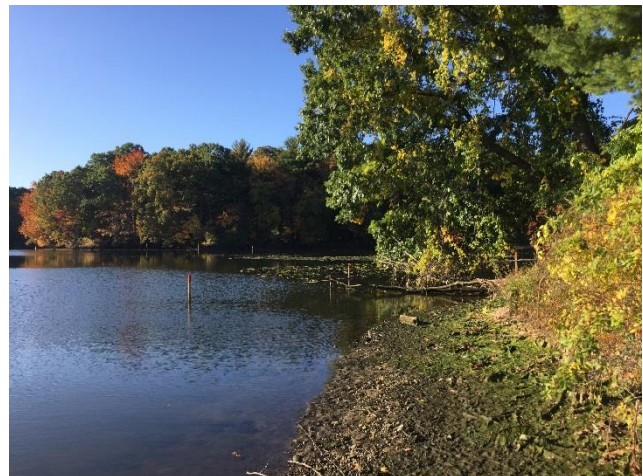
**Staging Area – Drawdown progress on Tuesday (6 days after initiation of drawdown).  
(10/15/2019)**

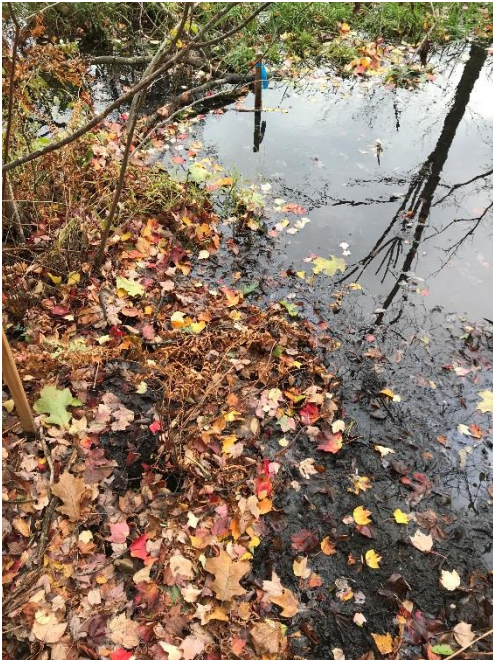
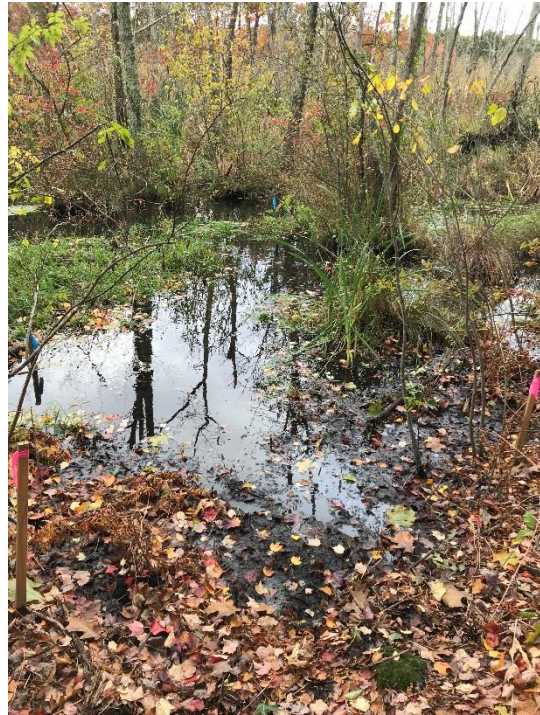
**Station 5.2 and 5.1 (L-R) (Whalen Property) – Edge of Bank shown. Turbidity, velocity, and sediment depth readings taken on Friday (9 days after initiation of drawdown). (10/18/2019)**

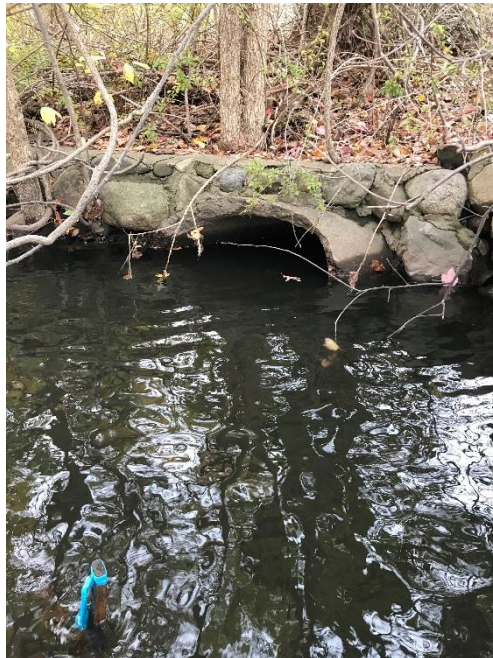
**Station 2 (West Street) – Turbidity, velocity, and sediment depth readings taken on Friday (9 days after initiation of drawdown). Stations similar to previous event. (10/18/2019)**

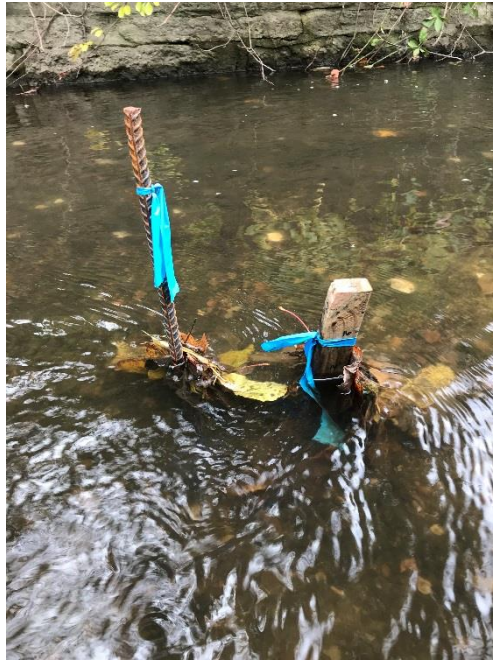
**Station 1 (Petrini Apartments) – Turbidity, velocity, and sediment depth readings taken on Friday (9 days after initiation of drawdown). Stations similar to previous event. (10/18/2019)**
